HOME INSPECTION REPORT

**123 Main St.
Anytown, NJ**

Inspection Date:
07/07/2010

Report Number:
DOE-07072010

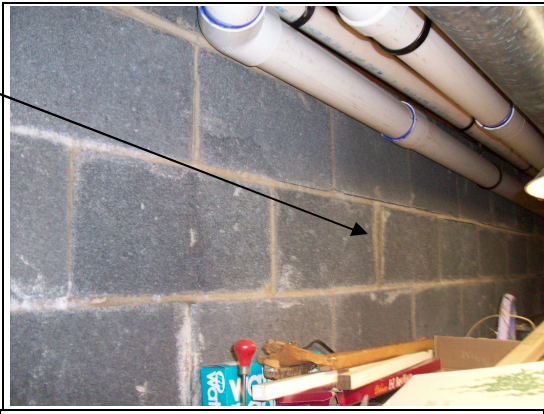
- **Monitor:** Common minor cracks were observed in the foundation walls of the house. This implies that some structural movement of the building has occurred, as is typical of most houses.
- **Monitor:** Minor horizontal cracking was observed at the basement foundation on the rear wall of the garage. The size of these cracks does not suggest a serious structural problem. If these cracks should worsen, a structural engineer or qualified contractor should be consulted to assess this condition and the remedies available for correction.

Horizontal Cracking Rear Foundation Wall of Garage

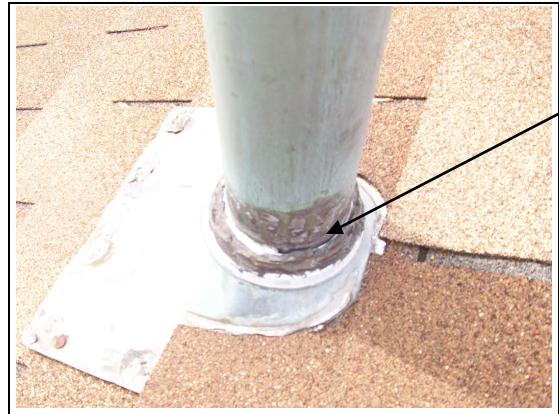
- **Major Concern:** The vent pipe flashings of the house are cracked or damaged. They should be repaired or replaced to prevent leakage.
- **Improve:** The chimney and vent pipe flashings are older and have been patched or coated and should be monitored. If leakage occurs, patching could be attempted. If this is unsuccessful, replacement may be necessary.

Gap at Vent Pipe Flashing

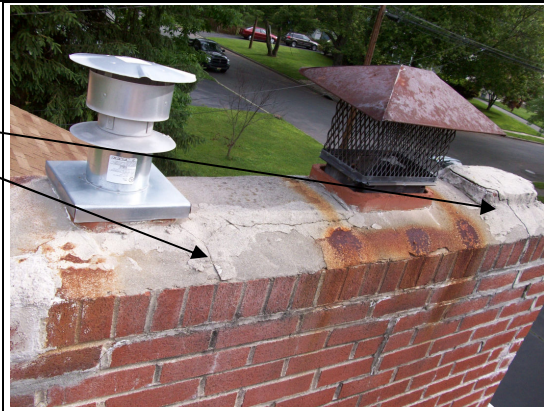
- **Major Concern:** The masonry chimney has loose and damaged bricks. Repairing the loose bricks and mortar joints is recommended to prevent further deterioration of the masonry chimney.
- **Improve:** The masonry chimney has a cracked cement wash, the coating on top the chimney. Repairs are recommended to prevent damage to the chimney masonry.

Cracked & Damaged Chimney Wash

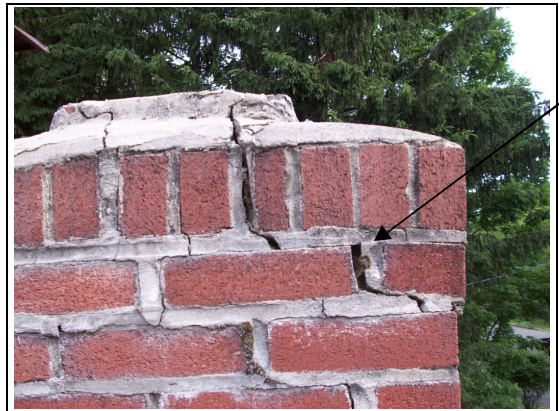
Damaged Mortar Joints && Loose Bricks

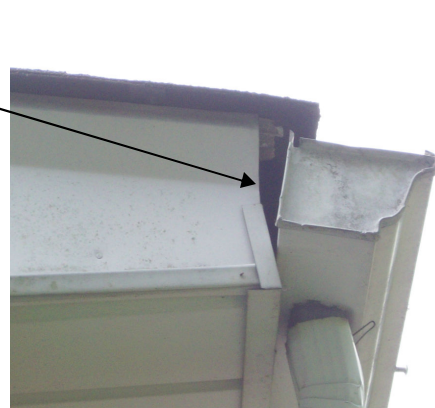
- **Improve:** Loose gutter on the rear of the house should be properly secured to prevent further damage to the gutter or leakage.
- **Improve:** The gutter on the rear of the house has a gap where it meets the siding. This gutter should have been terminated far enough from the house to install siding behind the gutter. Properly repairing the gutter and installing vinyl siding behind the gutter is recommended. At the very least this area should be properly sealed to prevent leakage behind the siding.
- **Improve:** The gutters require cleaning.
- **Improve:** The downspouts should discharge water at least five (5) feet from the house. Storm water should be encouraged to flow away from the building at the point of discharge.

Loose Gutter Rea of House

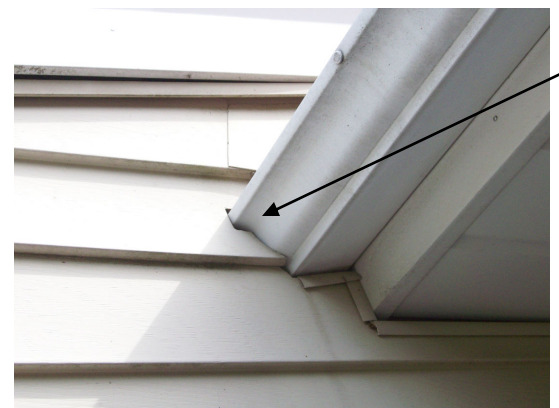
Gap at Siding at Gutter Rear of House

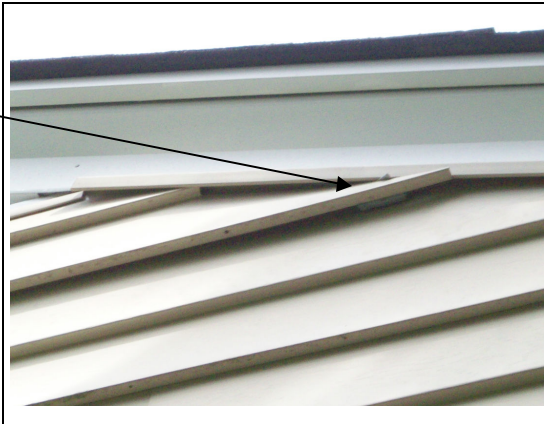
- **Improve:** The loose siding on the left side of the house should be re-secured. Loose siding can allow water enter and set the stage for possible rot and mold growth. Hidden damage may exist.
- **Improve:** Algae or mold growth was observed on the siding in several places. Cleaning the siding is recommended.
- **Improve:** Vegetation and vines growing on or within 6 inches of exterior house and garage walls in various locations should be kept trimmed away from siding, window trims, and the eaves. Vegetation can grow up behind siding and cause damage. Carpenter ants can also use this vegetation as a pathway to enter the home.

Loose Siding Left Side of House

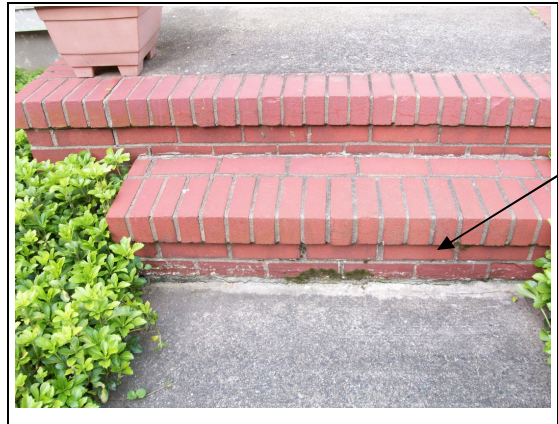
- **Improve:** The front porch has an unequal riser height. This unequal riser may present a trip hazard. These conditions may be costly to repair, in some cases the steps and or walkway at the steps need to be replaced. These repairs may not be practical. It is recommended that this condition be repaired for safety.

Unequal Riser Front Porch

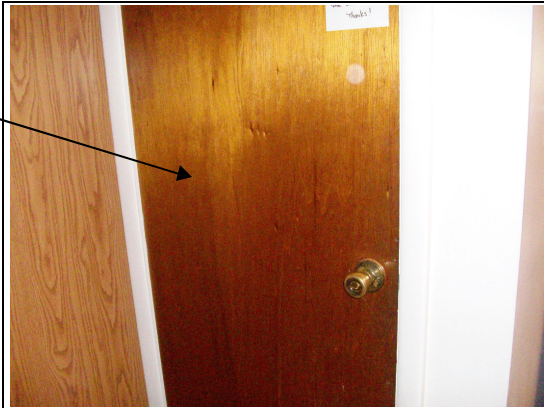
- **Safety Issue:** The door between the garage and the interior of the house should be rated to resist fire. Hollow core doors do not meet this requirement.
- **Safety Issue:** The garage door opener did not automatically reverse under resistance to closing. *There is a serious risk of injury, particularly to children, under this condition.* Improvement may be as simple as adjusting the sensitivity control on the opener. This should be dealt with immediately.

Garage To House Door Not Fire Rated

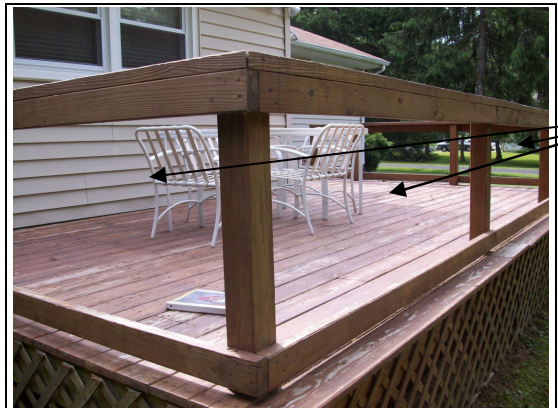
- **Safety Issue:** The openings in the deck railings are large enough to allow a child to fall through. It is recommended that this be altered for improved safety.
- **Improve:** The deck railing is too low. It is recommended that this condition be altered for improved safety. This is common in older homes.

Deck Railing Low & Openings Too Wide

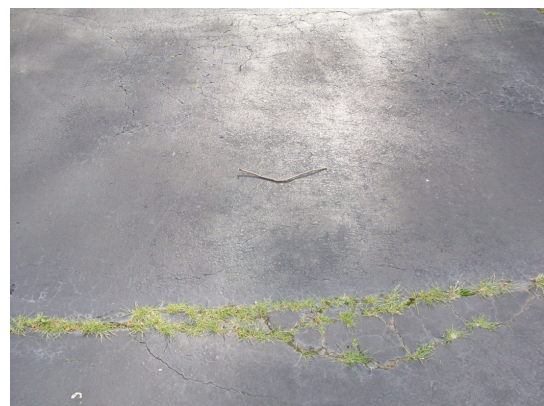
- **Improve:** The driveway has settled relative to the curb and presents a minor trip hazard. This condition should be altered for improved safety.
- **Improve:** The driveway surface has cracks. Filling the cracks is recommended. Resurfacing may be necessary to correct this condition in the future.

Driveway Cracks

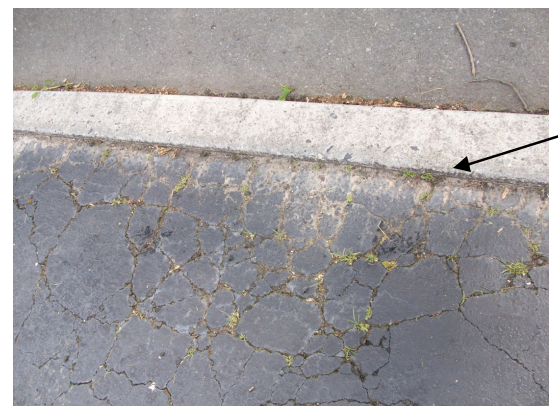
Driveway Settled at Curb ing

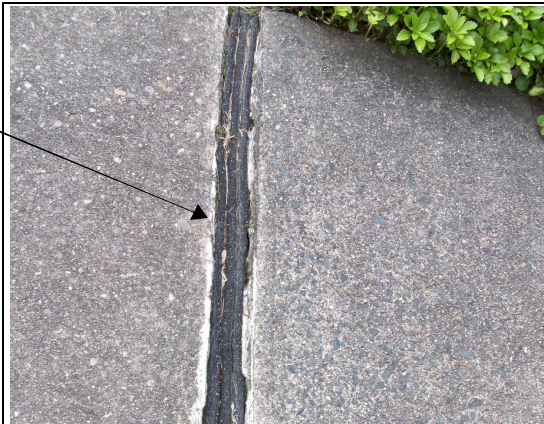
- **Improve:** The front walkway has a large gap and may present a trip hazard. This condition should be altered for improved safety.

Large Gap in Front Walkway

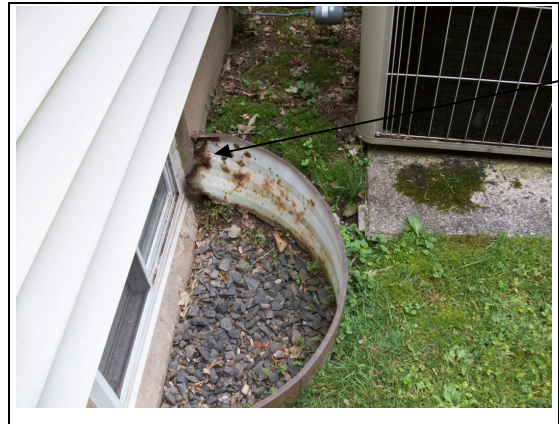
- **Improve:** The grading should be improved to promote the flow of storm water away from the house. This can usually be accomplished by the addition of top soil. The ground should slope away from the house at a rate of one inch per foot for at least the first ten feet. Ideally, at least eight (8) inches of clearance should be maintained between soil level and the top of the foundation walls.
- **Improve:** Basement steel window wells should be improved. Window wells protect basement windows from surface water and prevent contact with the soil.
- **Improve:** Covers should be provided for basement window wells to prevent storm water from accumulating within the well.

Window Wells Deteriorated

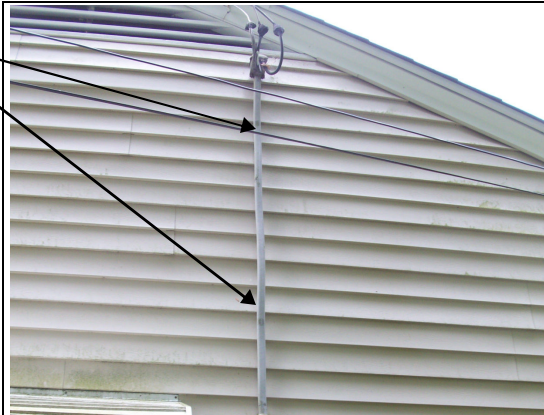
- **Major Concern:** The service entrance cable is damaged. This has allowed water to enter the main panel. It is recommended that this incoming service cable be replaced.
- **Improve:** The service entrance cable should be properly secured to the exterior of the home. It is recommended that more clamps be installed on the service entrance cable.

Clamps Needed on Main Cable

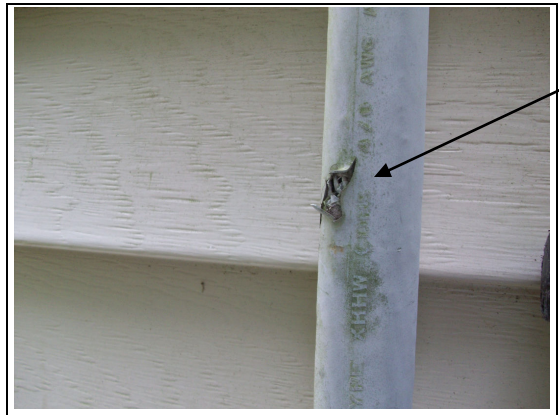
Main Cable Damaged

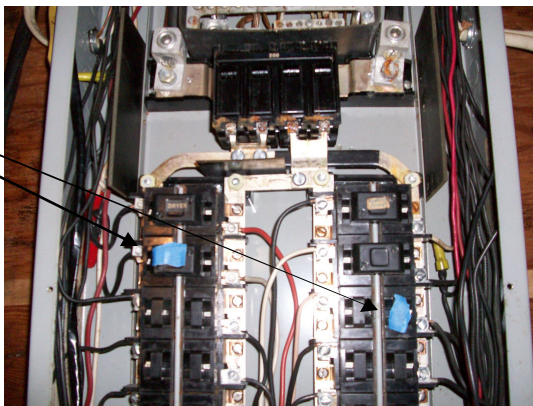
Over Sized Breaker & Double Tap

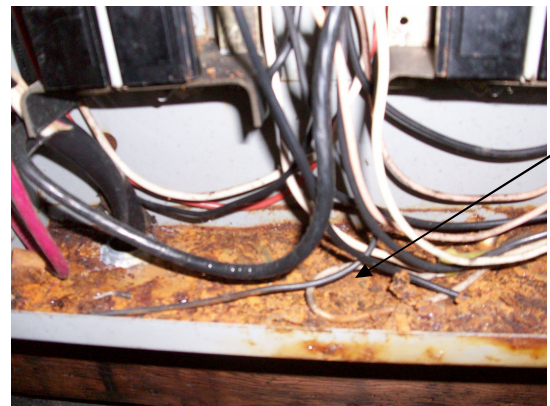
- **Major Concern:** The main distribution panel shows evidence of rusting, suggesting the presence of moisture. An electrician should be consulted before closing to locate where the water is entering the panel and what repairs should be undertaken. This panel and its breakers should be replaced.
- **Safety Issue:** Oversized breakers within the main distribution panel should be replaced. All breakers should be appropriately sized according to wire gauge. (Marked with Blue Tape).
- **Improve:** Circuits within the main distribution panel that are doubled up (referred to as “double taps”) should be separated. Each circuit should be served by a separate fuse or breaker. (Marked with Blue Tape)
- **Improve:** It is recommended that the aluminum main service wiring at the main breaker connections be coated with an anti-oxidant to protect the wiring from oxidation damage.

Major Rust in Main Electrical Panel

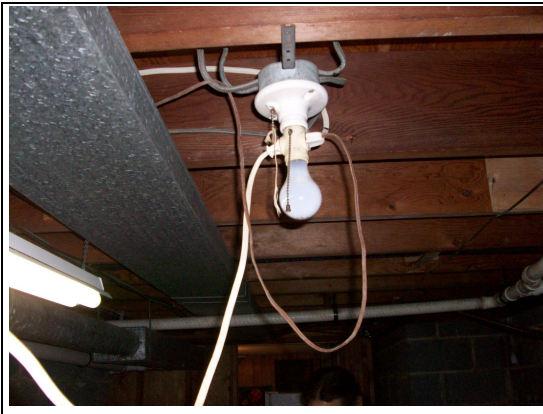
- **Safety Issue:** Extension cords should not be used as permanent wiring or run through walls. It is recommended that these extension cord wires be removed and hard wired outlets be added where needed. Observed in the basement in several places.
- **Improve:** The water heater is not bonded. Bonding the water heater is recommended.
- **Improve:** The water meter is not bonded. Bonding the water meter is recommended.

Extension Cord Wiring in Basement

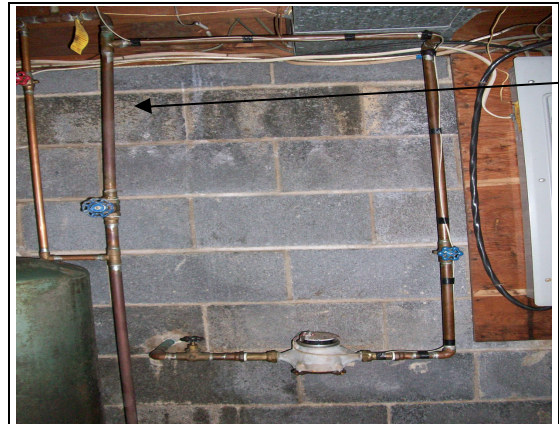
- **Major Concern:** A potential "cross connection" was observed at the connection between the public and well water in the basement near the meter. A cross connection exists whenever there is potential for public potable water to contact a source of contamination (well water). It is recommended that the well water line be totally disconnected from the public water system for the safety of the public water system.

Well & Public Water Connection

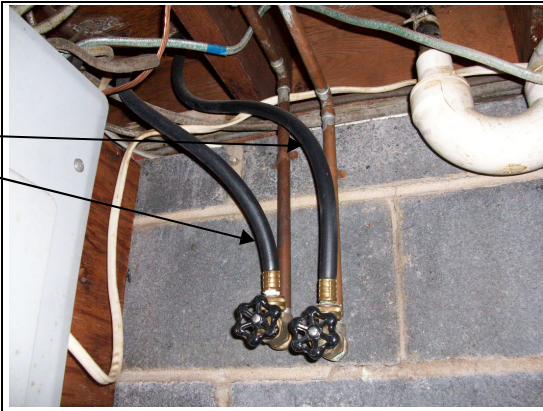
- **Improve:** The clothes washer rubber supply lines have been run through the floor. These lines were not designed and are not rated for this purpose. It is recommended that these rubber hoses be removed and proper supply lines with shut off valves be installed behind the washing machine.

Washer Feed Hose Run Through Floor

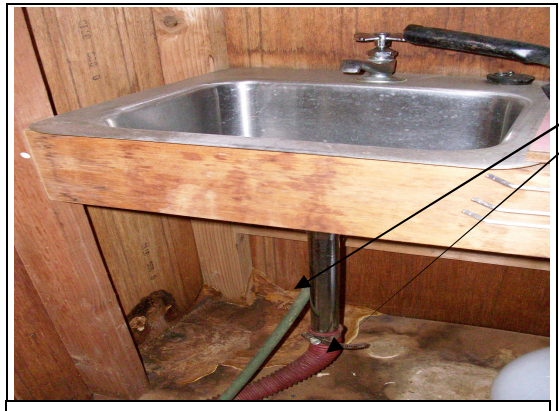
Bar Sink Fed by Garden Hose & Drains into Sump Pit

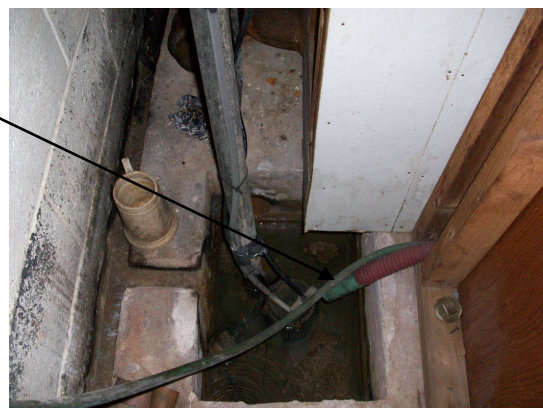
Bar Drain in Sump Pit

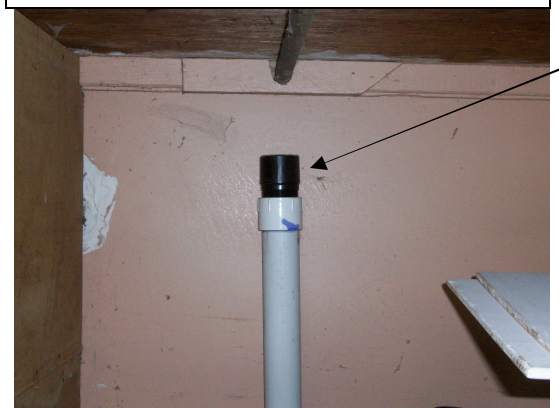
- **Improve:** An improper vent pipe and fitting was observed in the garage. Properly venting this drain piping is recommended.

Improper Vent for Washer in Garage

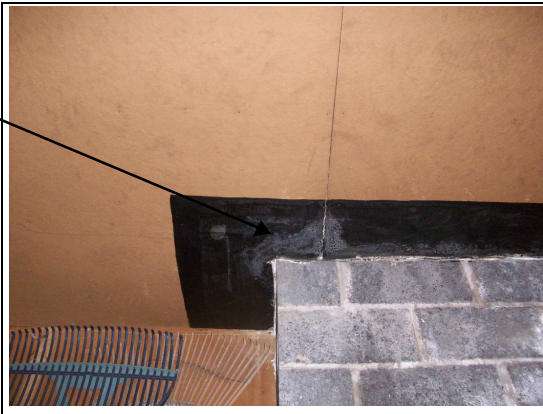
Prior Water Damage in Garage at Chimney

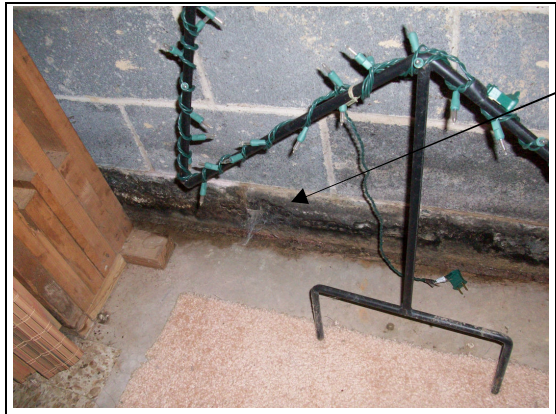
Possible Mold in Basement on Walls

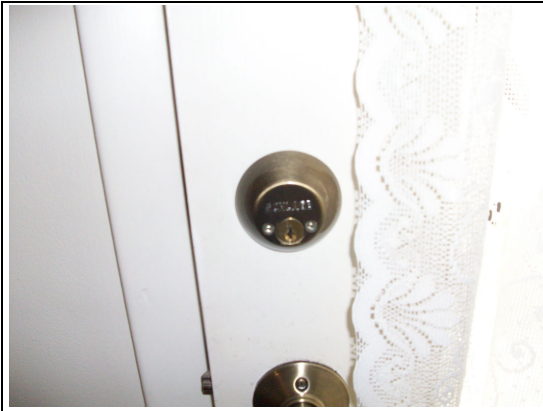
- **Safety Issue:** The front, rear and garage exterior doors have key operated dead bolts on the inside of the doors. This could delay an emergency exit from the house if an emergency should arise. Replacing these key locked dead bolts with a thumb turn style on the inside of the door is recommended for safety.

Key Locked Dead Bolts on Interior of Exit Doors

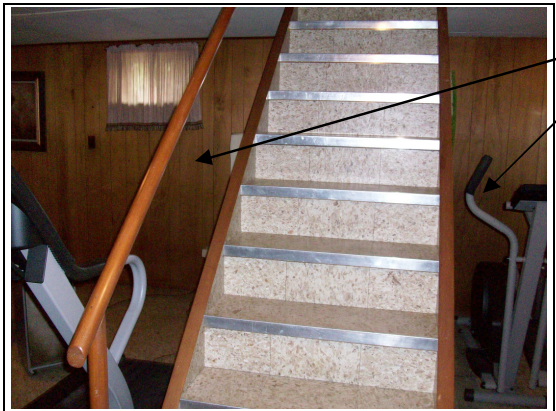
- **Safety Issue:** The openings in the basement stairway railing are large enough to allow a child to fall through. It is recommended that a graspable railing with properly spaced balusters be added to both sides of the basement stairs for improved safety.

Basement Rail Openings Too Wide
