# HOME INSPECTION REPORT

**123 Main St  
Yourtown, NJ**

**Inspection Date:**  
05/08/2010

**Report Number:**  
SMI-06062010-144

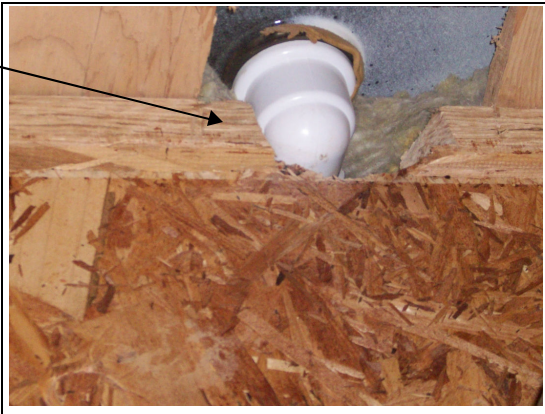
I-Joist Cut at Plumbing Fitting

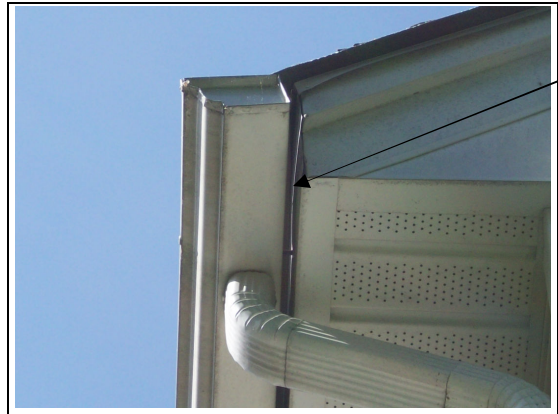
- **Improve:** Loose gutter on the right rear corner of the house should be properly secured to prevent further damage to the gutter or leakage.
- **Improve:** The downspouts should discharge water at least five (5) feet from the house. Storm water should be encouraged to flow away from the building at the point of discharge.

Loose Gutter Rear Right Corner of the House

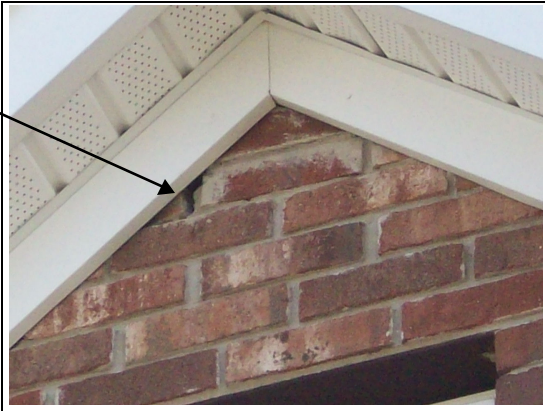
- **Improve:** The exterior brickwork near the peak of the house should be re-pointed as needed (replacement of the mortar between the bricks).
- **Improve:** Algae or mold growth was observed on the siding in several places. Cleaning the siding is recommended.
- **Improve:** The lintels (in effect, the metal beams supporting the brickwork above openings in a wall) should be painted.
- **Improve:** Vegetation and vines growing on or within 6 inches of exterior house and garage walls in various locations should be kept trimmed away from siding, window trims, and the eaves. Vegetation can grow up behind siding and cause damage. Carpenter ants can also use this vegetation as a pathway to enter the home.

Missing Mortar Joint

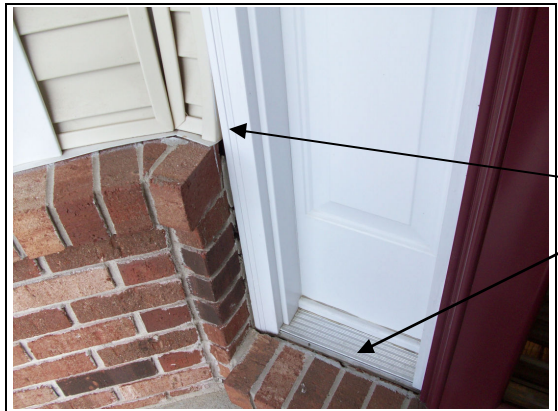
- **Major Concern:** The front door frame appears to have settled and is causing bowing of the siding at the brick veneer. No visible evidence of support failure was visible under this door in the basement area. This door frame should be further investigated and any needed repairs performed prior to closing.

Front Door & Frame Has Settled & Siding is Bulging

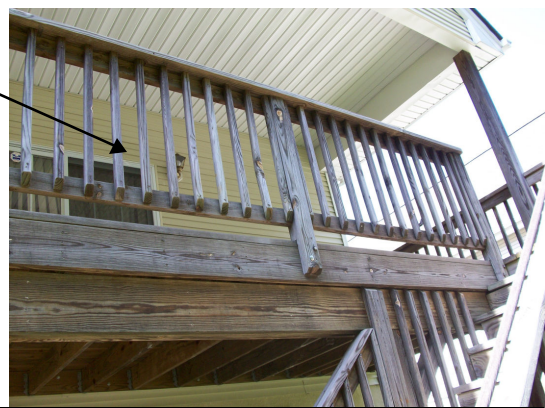
- **Safety Issue:** The rear deck railing is loose. It is recommended that this be repaired for improved safety.
- **Safety Issue:** The balusters are installed on the outside of the railing. It is recommended that these balusters be better secured or moved to the inside of the railing for added strength for added safety.
- **Improve:** It is recommended that beam to joist connectors be installed to the deck to prevent possible up lift.
- **Improve:** The support posts for the deck should be properly connected to the beams with beam to post connectors for added safety.

Railing Loose & Balusters on Outside of Railing
